Capital Region Water

CONSULTING ENGINEER'S ANNUAL REPORT

Water System

October 3, 2016

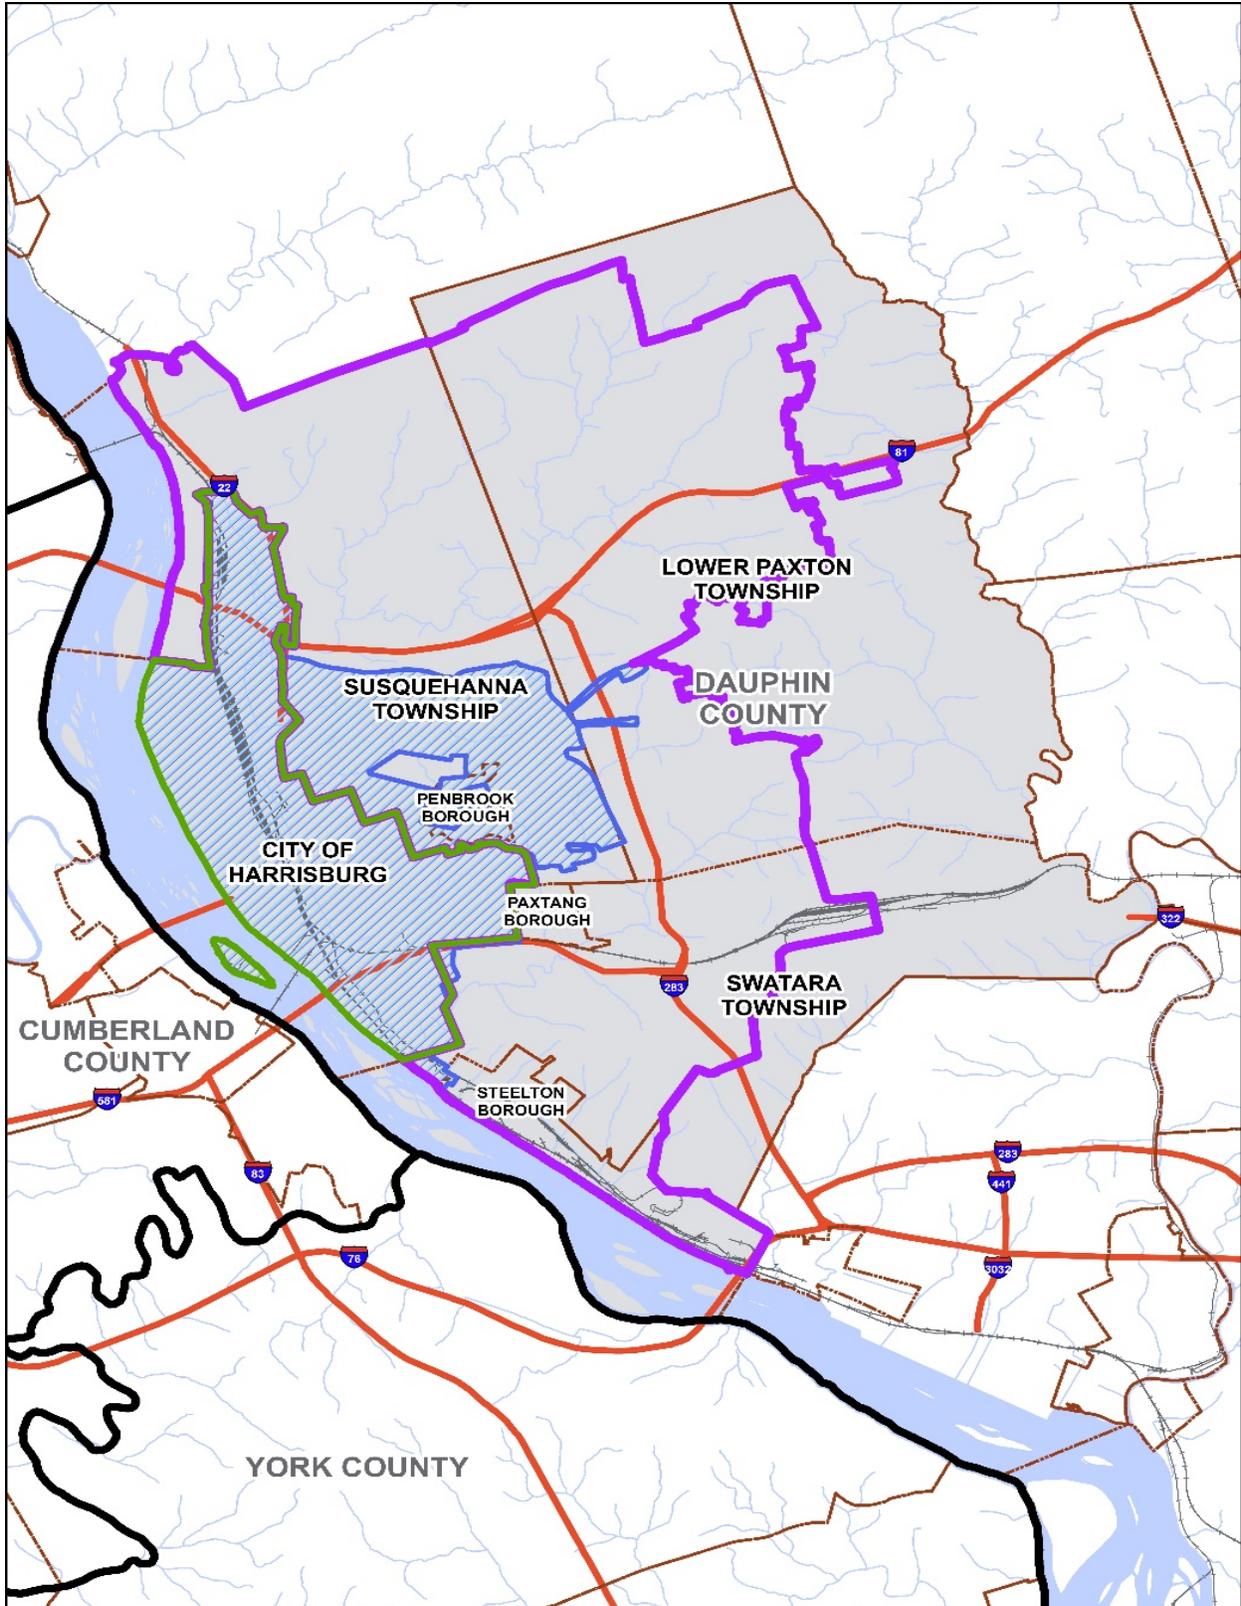
The service area of the Water System includes the City of Harrisburg and portions of Penbrook Borough, Lower Paxton Township, and Susquehanna Township. A map showing the Water System's service area is included below.
