Capital Region Water

**CONSULTING ENGINEER'S ANNUAL  
REPORT**

Water System

September 30, 2019

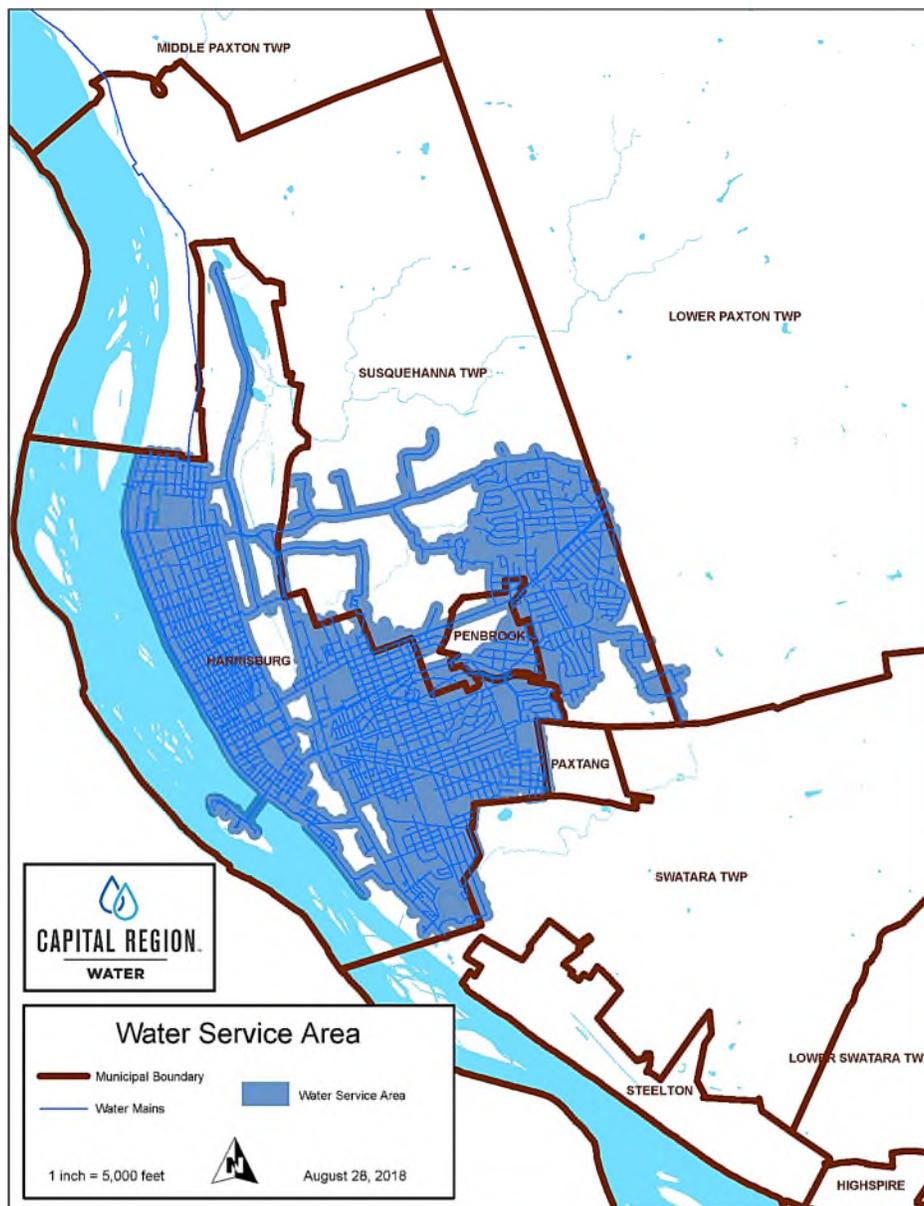
Figure 3-1: Water System Infrastructure Map

The service area of the Water System includes the City and portions of Penbrook Borough, Lower Paxton Township, Swatara Township and Susquehanna Township. Except for some distribution system piping and related equipment, the majority of CRW's water assets are located within the municipal boundaries of the City. Figure 3-1 below shows the water system infrastructure map.
